**EFFECTS OF STATE ROUTE 23 WIDENING PROJECT AND  
ACCOMPANYING MITIGATION MEASURES ON  
CULVERT USE AND ROAD MORTALITY OF WILDLIFE**

**FINAL REPORT**

**NATIONAL PARK SERVICE  
SANTA MONICA MOUNTAINS NATIONAL RECREATION AREA**

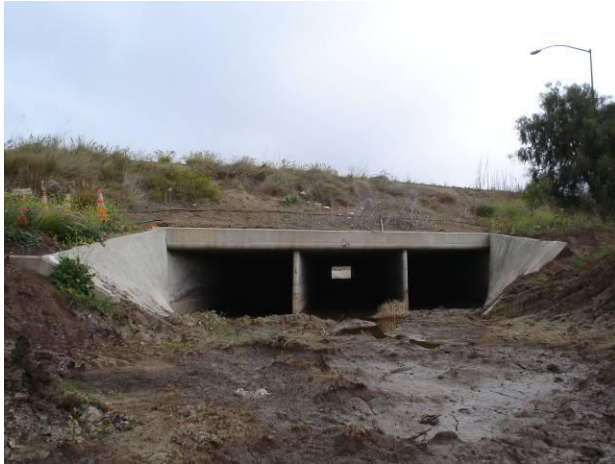
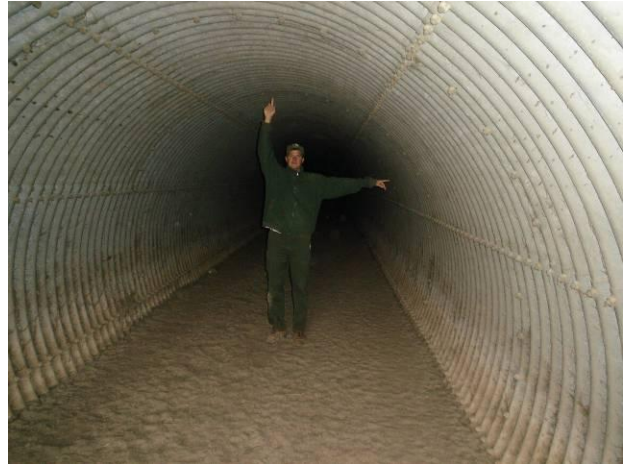
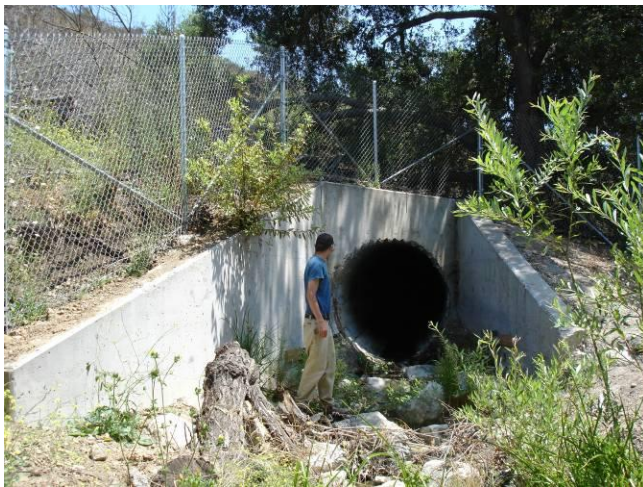
**Figure 2.** Three culverts along SR 23 study area.

The 3 underpasses (Figure 2) along the study area were drainage culverts that were originally placed there for hydrologic purposes. Culverts B and C were circular corrugated metal pipe culverts and culvert A was a concrete box culvert with two walls inside it running the length of the culvert and dividing it into 3 tunnels. Sediment filled approximately 75% of Culvert A prior to the Widening Project and was later cleared by Caltrans. Plant and sediment material filled approximately 85% of the western side of Culvert C prior to the Widening Project and clearing by Caltrans. Each of Culvert A's 3 tunnels was 83 m long, 3.2 m wide, and 0.6 m high pre-clearing and measured 3.2 m wide and 1.85 m high after being cleared with an openness ratio ( $\text{ht} \times \text{width/length}$ , commonly used in relation to wildlife passages; Reed et al. 1975) of 0.07 m, and

remained dry most of the year. Culvert B required no modification and was 140 m long, 3.2 m wide, and 2.8 m high (openness ratio=0.06 m) and remained dry most of the year. Culvert C was 110 m long, 1.45 m wide, and 0.6 m high pre-clearing and measured 1.45 m wide and 1.9 m high (openness ratio= 0.03 m) after being cleared and had (generally shallow) running water throughout the year. Culvert A was the only underpass that had visibility through the entire length of the culvert, allowing an animal to see the other end. Culvert B was the only underpass that had a dirt substrate along its entire length. Culvert A's floor was covered with dirt for half its length and bare concrete the remaining half, and Culvert C had a constant flow of water running through it at an average height of 8 cm. Culvert C was the only culvert that had natural vegetated areas leading up to both entrances.

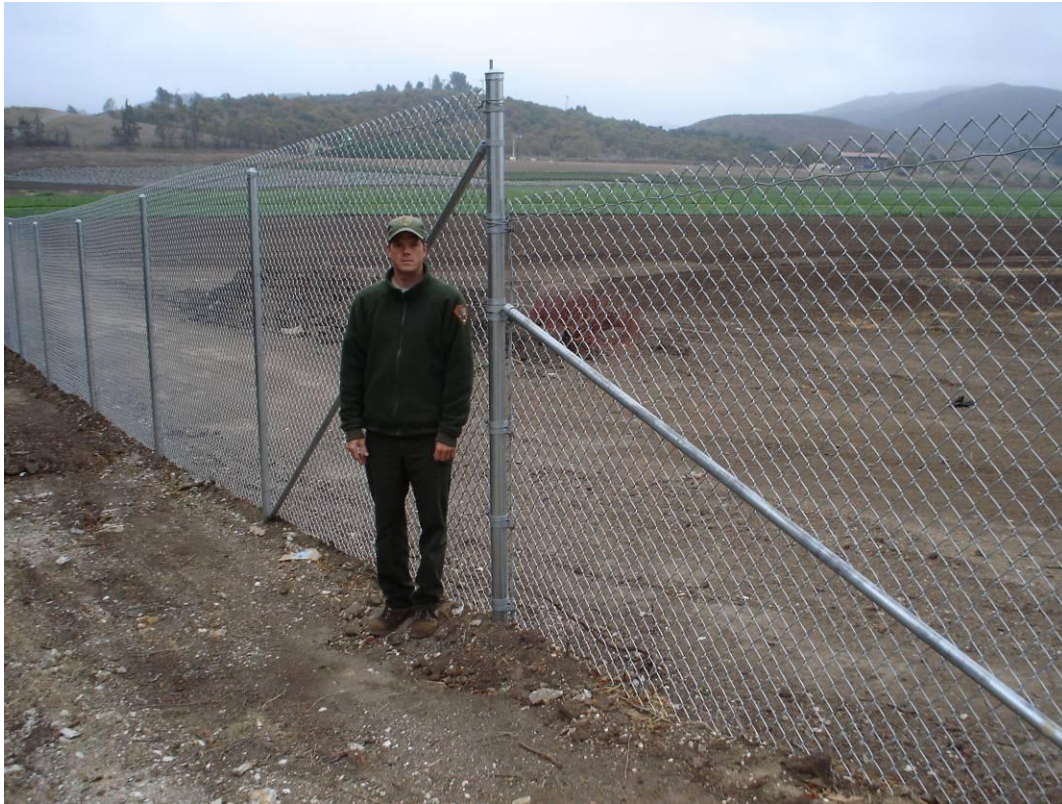
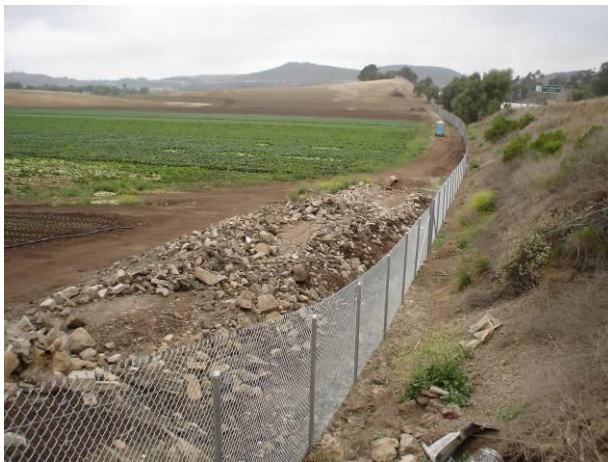
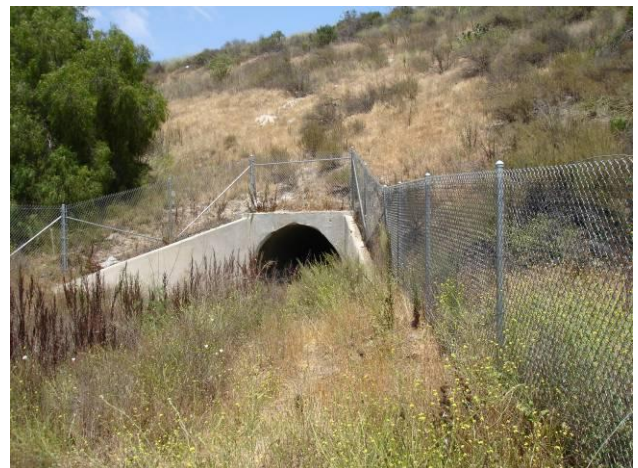
**Figure 3.** Chain-link wildlife exclusion fence buried 2 feet into the ground with a total height above ground of 6 or 8 feet.

Caltrans removed the existing right-of-way fence along both sides of SR 23, which was damaged in many locations, and replaced it with a new fence line along the same footprint. The new chain-link wildlife fence was designed to prevent wildlife from entering the road; it had a mesh size of 7 x 8 cm and was buried 0.6 m (2 ft) into the ground with a total height above ground of 1.8 m (6 ft) or 2.4 m (8 ft) depending on the slope (Figure 3). On both sides of the highway, fences were located at least 7 m from the road and as far away as 100 m. The fences ran parallel to the highway and continued above each of the 3 culverts to funnel animals into the culvert opening. During construction, twelve one-way gates (Figure 4) were also installed (6 on each side) along the fence line to allow animals that do get inside the fencing to escape.

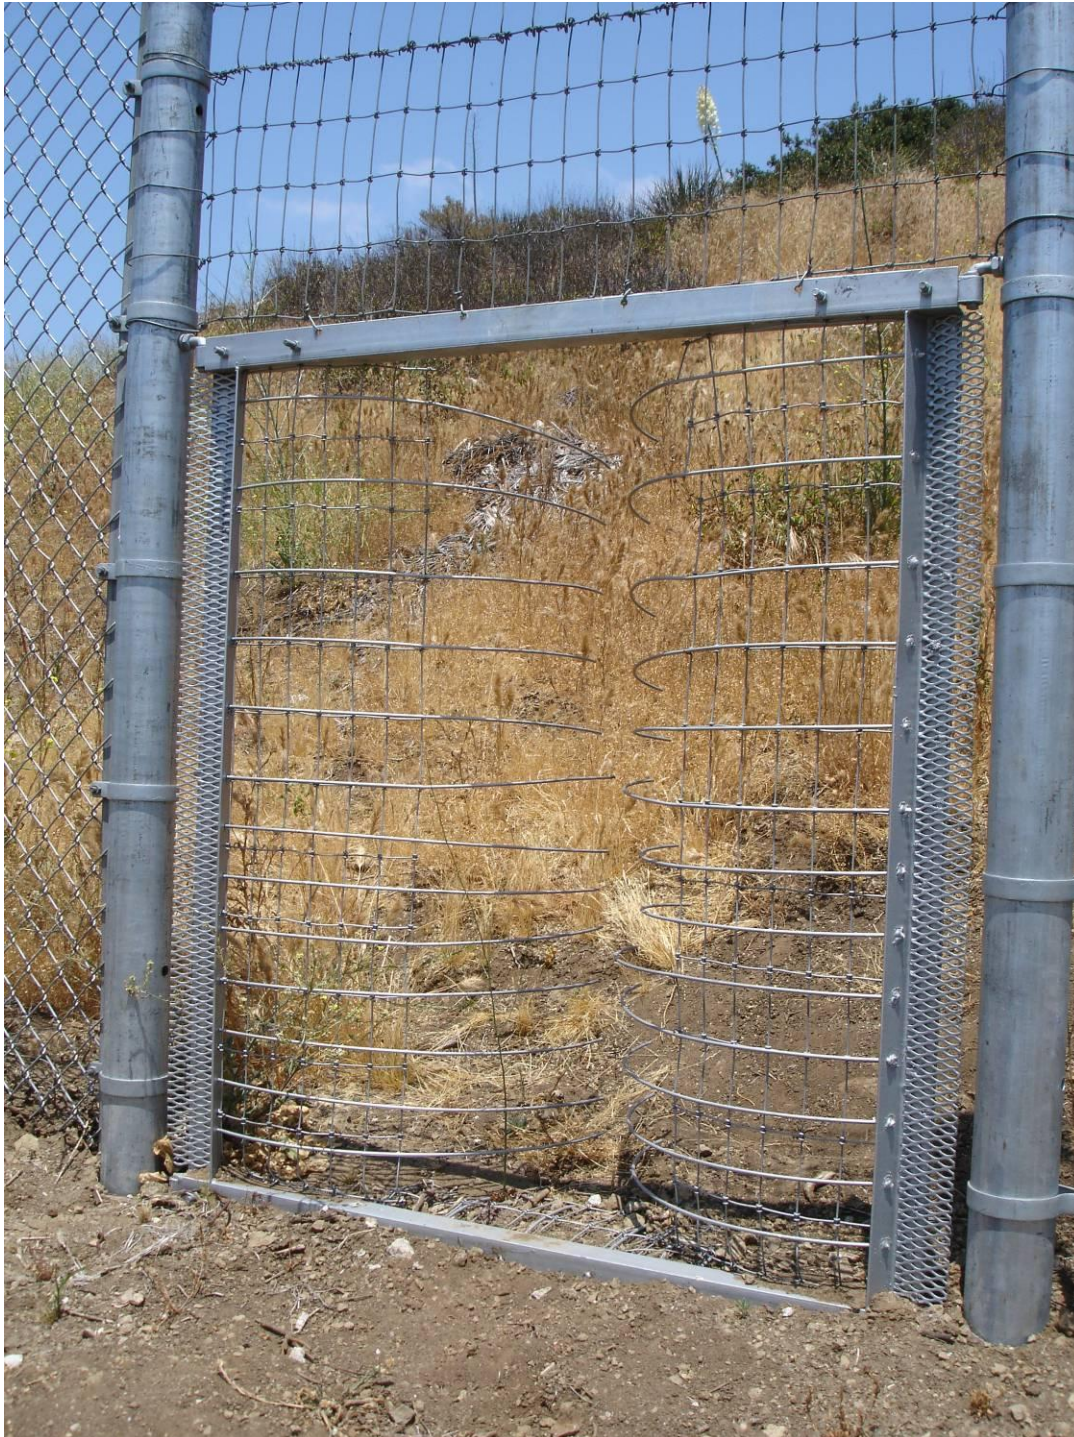
**Figure 4.** One-way gate designed to allow animals that are trapped inside the right-of-way to safely exit.

One-way gates were designed to allow easy passage from the road to outside areas, but little or no passage from the outside area to the road. Caltrans and the National Park Service (NPS) modified the one-way galvanized steel escape gate design commonly built for deer (Reed et al. 1974) to also apply to medium sized mammals, since no deer were detected in the study area during 3 years of pre-construction monitoring. Specifically, modifications included placing baler tines in the gates closer together at the bottom (bottom 61 cm spaced 8 cm apart; middle 31 cm spaced 10 cm apart; top 31 cm spaced 13 cm apart) and including 5 x 10 cm wire mesh that was secured on the tines nearest the gate ends extending out 31 cm to prevent flexibility that may allow animals to bend the tines and squeeze through (Figure 5). Tines were left open the remaining 5 cm to allow flexing at the point an animal would pass through the gate (Figure 6). The gate profile was lowered to ground level and chain link fence material was installed at the bottom of the gate and buried 0.6 m to prevent animals from digging under it. Gaps between the fence and gate frame were closed to no larger than 4 cm.

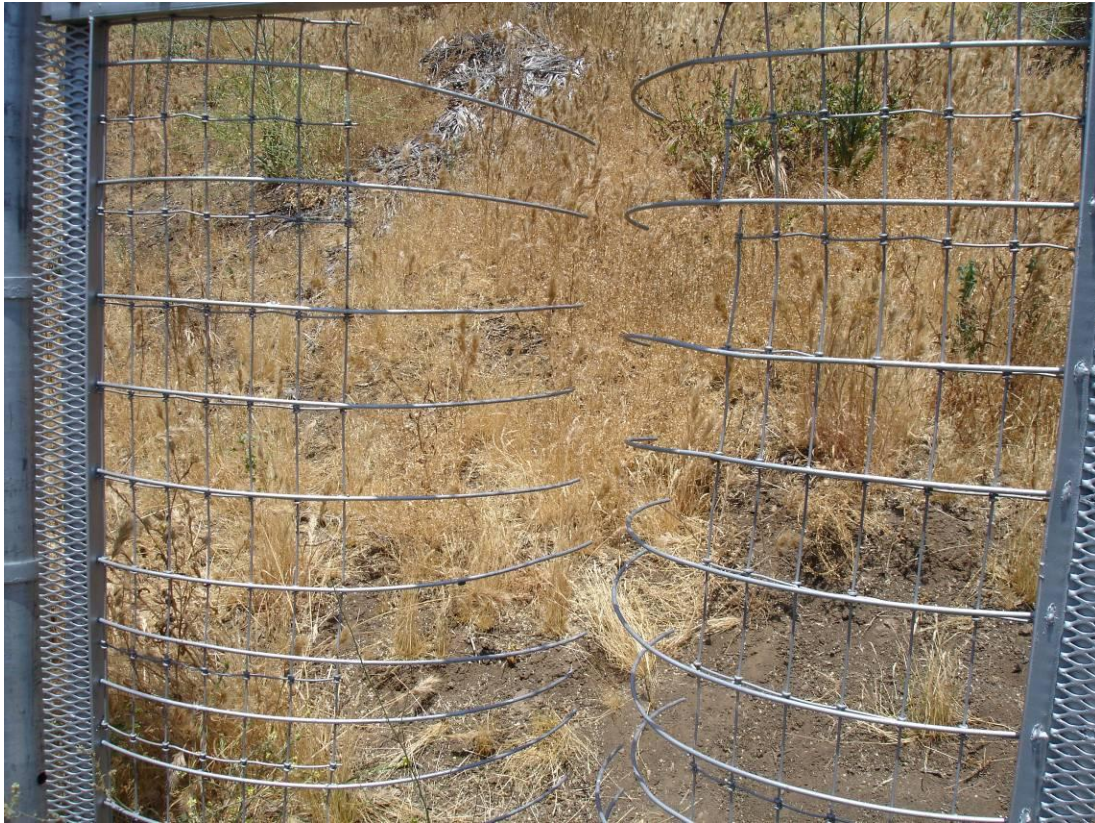
**Figure 5.** Wire mesh secured on the one-way gate tines to prevent flexibility that may allow animals to bend the tines and squeeze through.

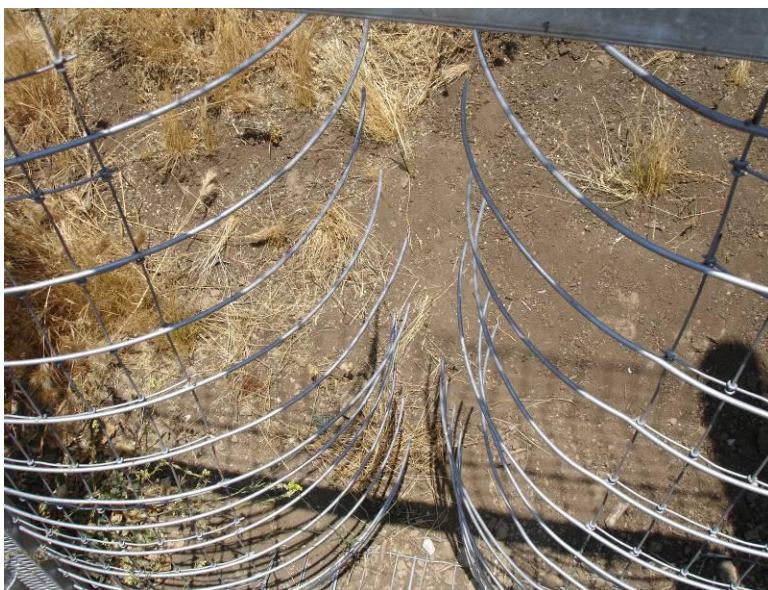
**Figure 6.** Gap between tine ends to allow flexing at the point an animal would pass through.

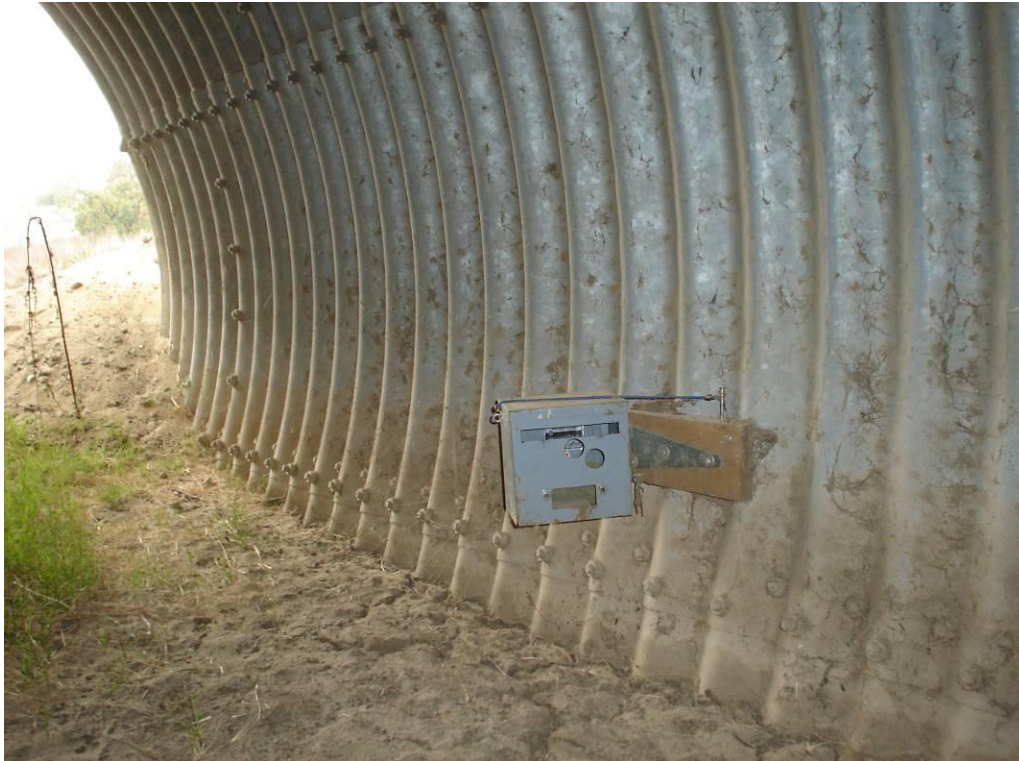
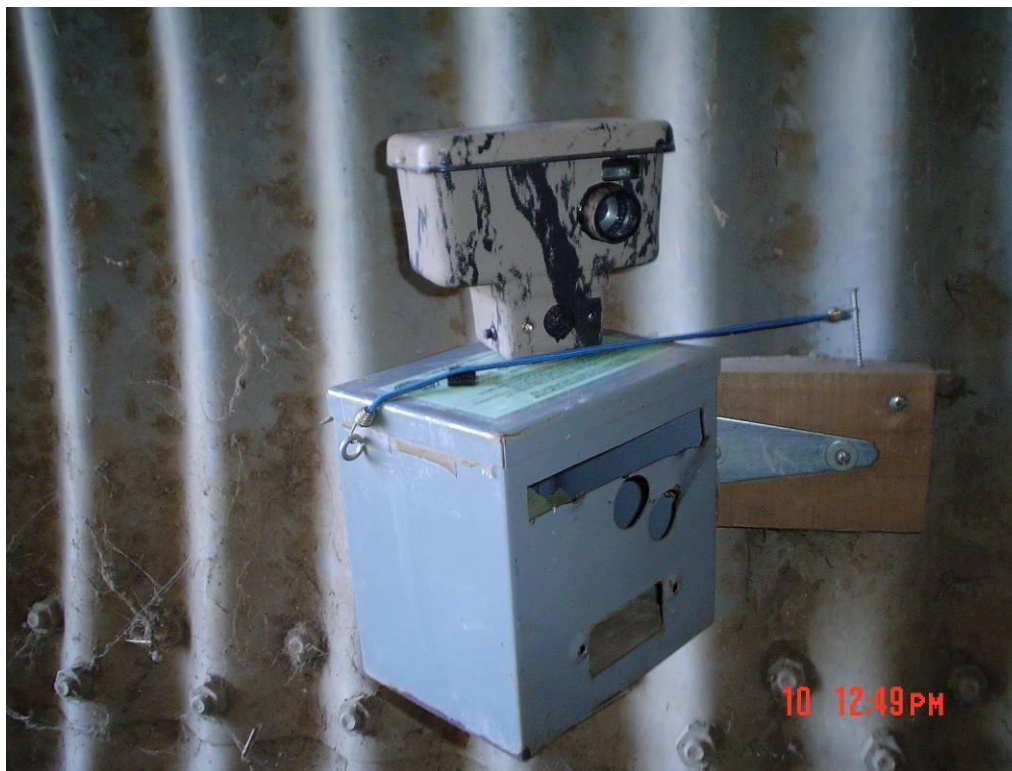
**Figure 7.** Digital remote camera secured in steel container used to monitor culvert use.

Digital CamTrakker remote cameras were used in the culverts during our pre-construction monitoring. These cameras had a delay of approximately 2 seconds between the time an animal

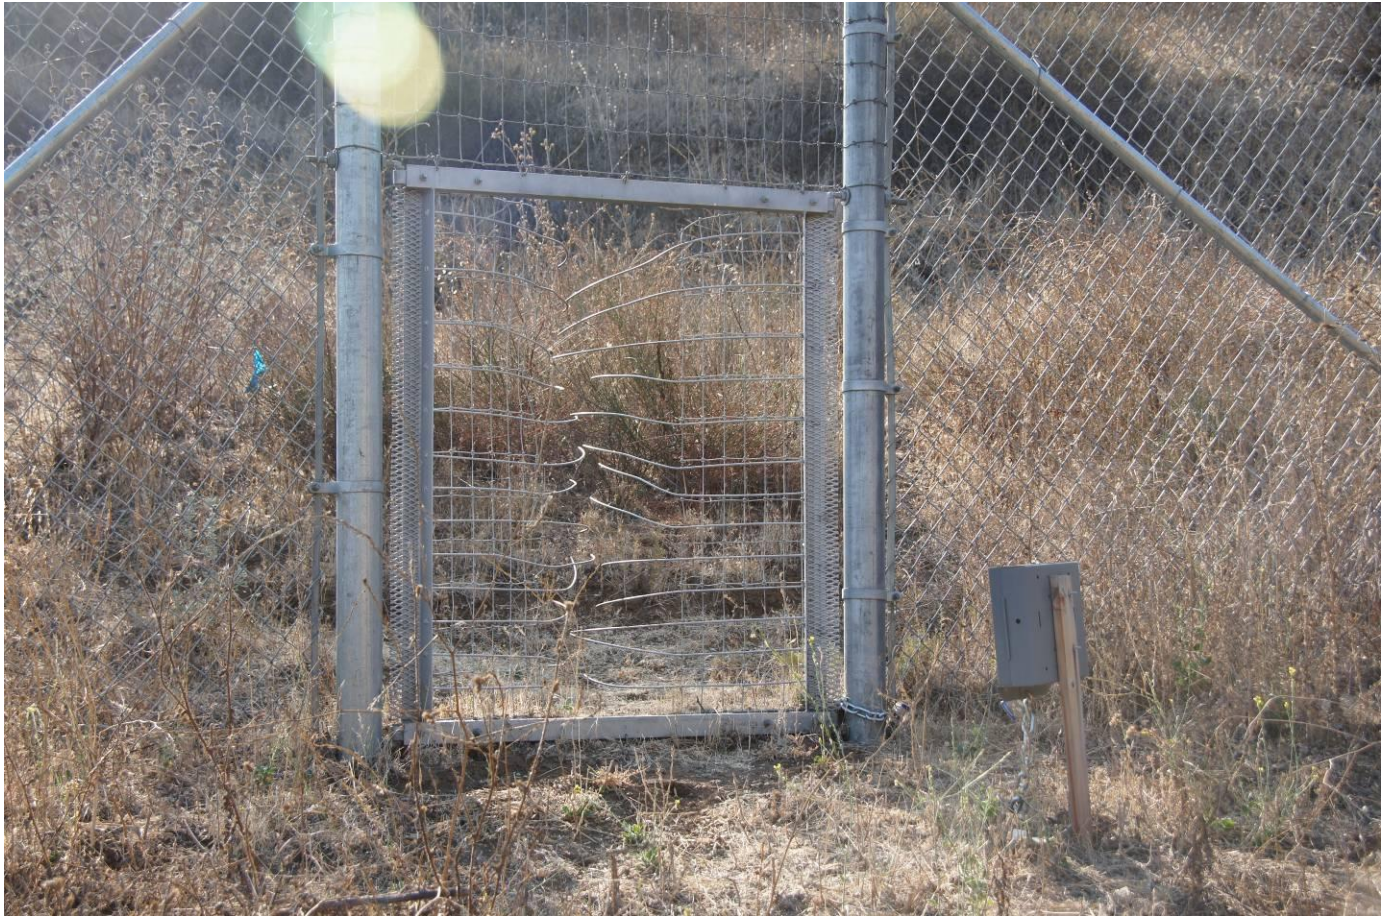
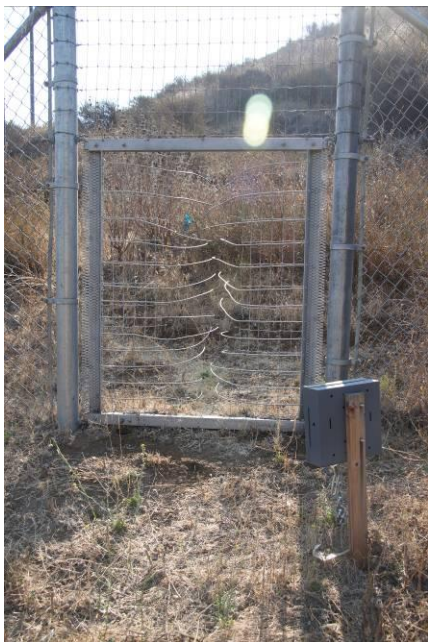
**Figure 8.** Digital remote camera used to monitor one-way gate use.

We monitored all 12 one-way gates for 1 year from August 12, 2010 to August 12, 2011 with Reconyx PC90 remotely triggered infrared digital cameras. Monitoring of the six gates on the east side of SR23 began six months prior to this time period, on February 17, 2010, resulting in a total monitoring time of 18 months for the east side gates. The fast camera speed of these cameras allowed us to detect animal behavior at each one-way gate. One camera was placed 1.5 m in front of and to the side of each one-way gate at a height of 45 cm from the ground to record any animal use (Figure 8). Cameras were located along the inside (freeway side) of the fence line, secured in steel containers that were fastened to a wooden stake driven into the ground, and locked with a 2 meter section of steel chain to a fence post. Media cards and batteries were changed at least every 2 months, with more frequent camera visits at sites that needed more maintenance. The only mammals recorded in our analysis were those that could not fit through the mesh size of the chain link fence (e.g. small mammals, such as mice were not monitored). Occasions occurred during the post-construction monitoring when the cameras were not activated because of depleted batteries and full memory cards. We measured one-way gate use by dividing the number of pictures taken of animals going through (in either direction) or walking by the gate by the number of nights the camera was active.

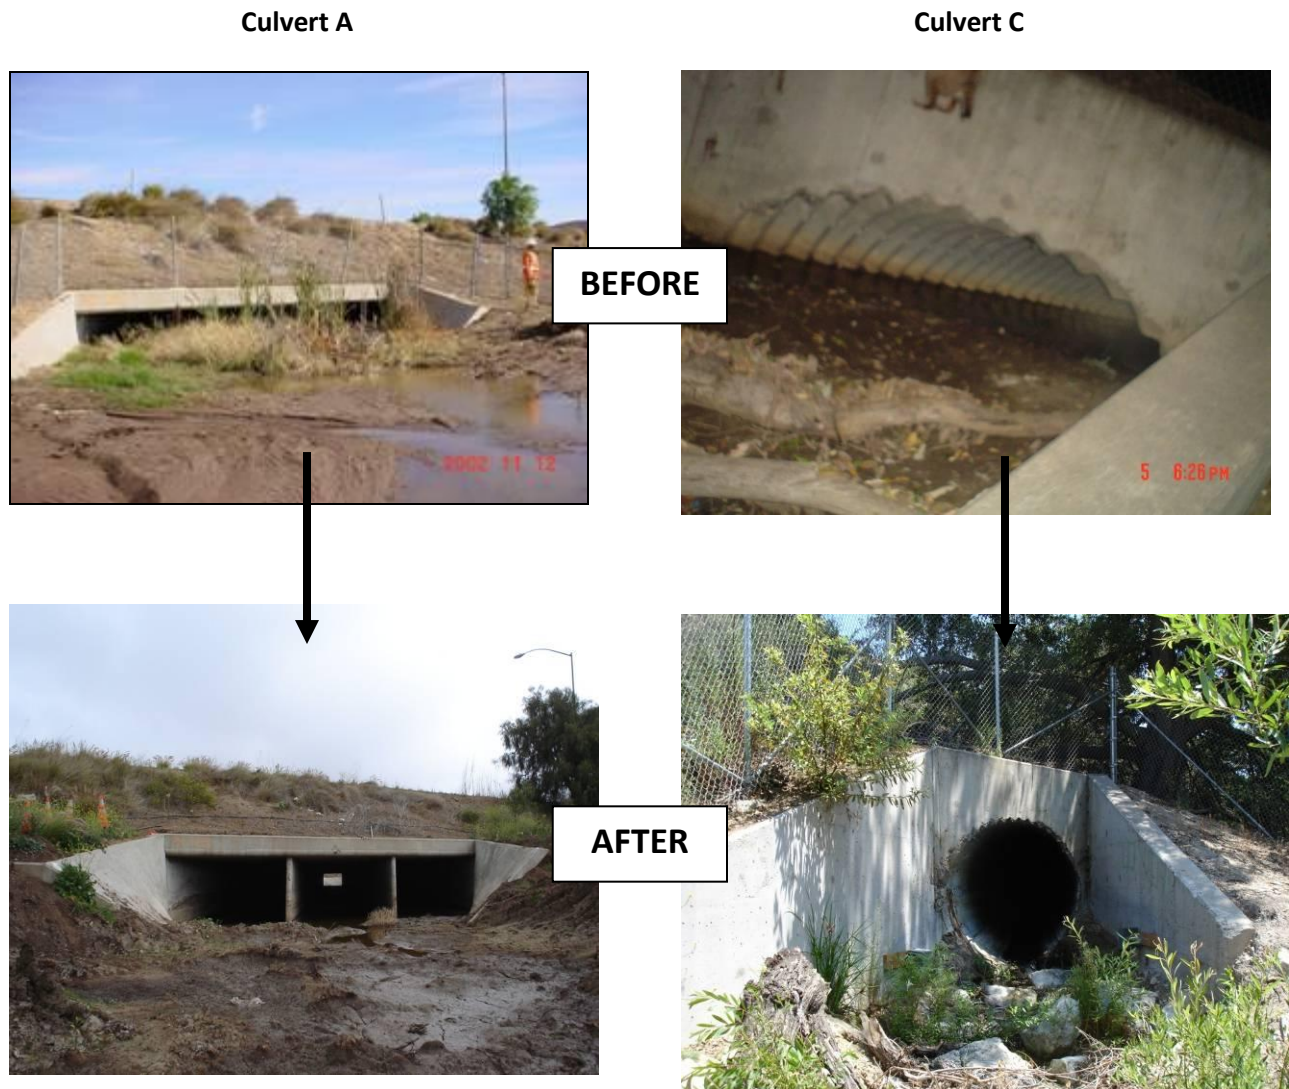
**Figure 12.** Culverts A and C before and after being cleared.

After the construction period and the mitigation measures were completed (the wildlife proof fence was built and Culverts A and C were cleared, Figure 12), remote cameras recorded 5820 photos, of which 5110 were animals and 710 were “trip” events (Table 3). Skunks (30%) and coyotes (21%) accounted for most of the animal pictures (Figure 13); other species recorded in all three culverts were bobcat, raccoon, opossum, rabbit, and ground squirrel (*Otospermophilus beecheyi*). The highest percentage of animal pictures taken were of rabbits (35%) and coyotes (12%) in Culvert A, of skunks (51%) and coyotes (23%) in Culvert B, and of raccoons (33%) and skunks (16%) in Culvert C. Culvert B had the highest wildlife use with cameras taking 3.54 photos/monitoring day, while 0.72 photos/monitoring day were taken in Culvert A and 0.92 photos/monitoring day were taken in Culvert C (Table 3). Coyotes also used Culvert B nearly every day with 0.8 coyote photos/monitoring day. Remote cameras recorded 321 (642 photos) confirmed crossings by coyotes, raccoons, skunks, and opossums (Table 4), with coyotes and raccoons passing through all 3 culverts. Coyotes accounted for most (61%) of these crossings. Mammals were photographed at all times throughout the 24 hour period, however 188 (52%) of the confirmed crossings occurred between the hours of 5am and 9pm (i.e. during the day).

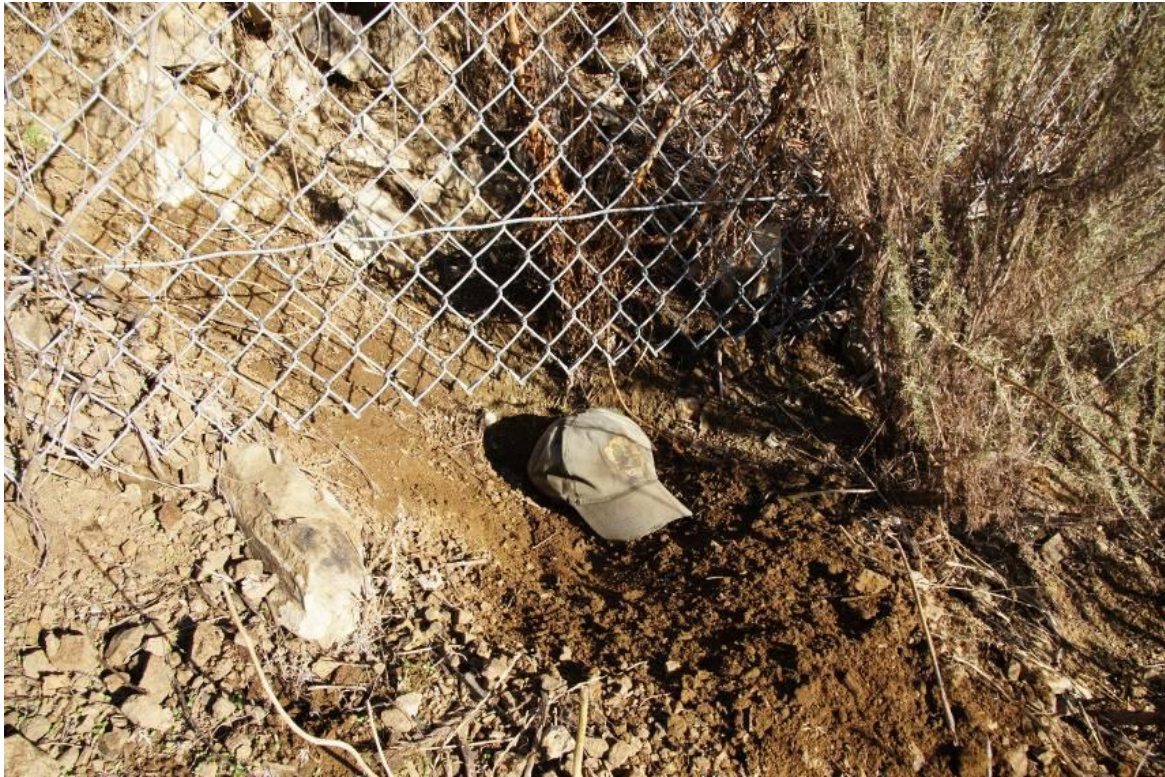
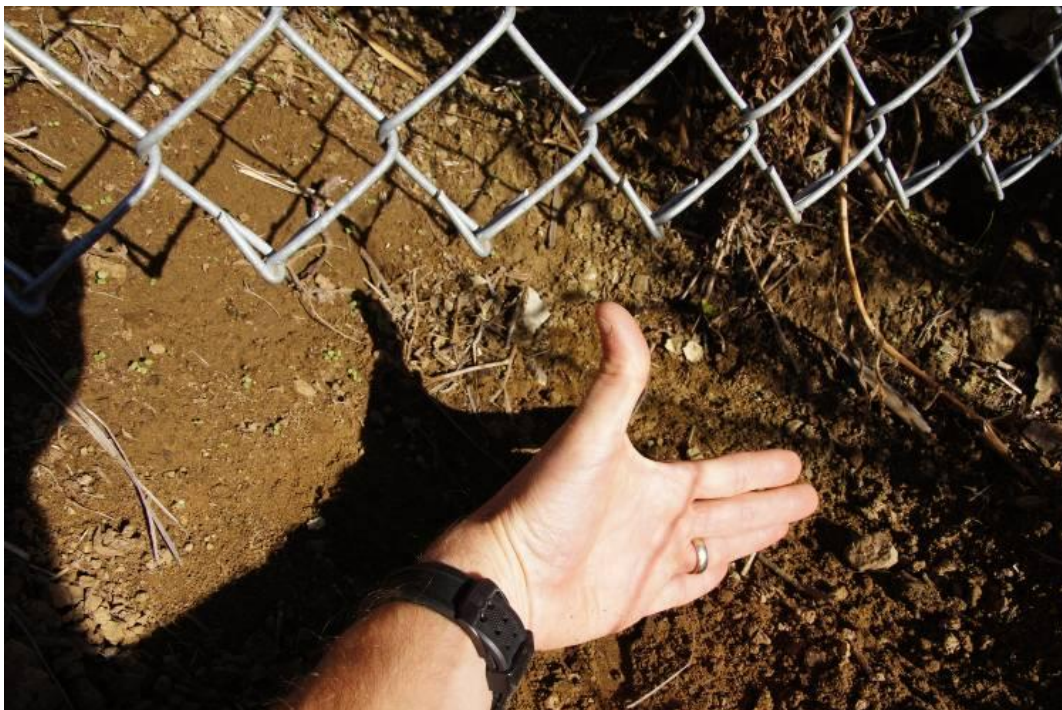
**Figure 23.** 23cm gap under the wildlife exclusion fence. Tracks of coyote and raccoon have been found at this location going under the fence and accessing the right-of-way.

**A. The wildlife proof fence requires regular inspection and repair to ensure that animals are not exploiting breaks in the fence.** Fence maintenance is usually neglected after construction, yet it is important to conduct even with budgets and priorities of transportation agencies changing over time (Forman et al. 2003). Fences are not permanent structures and can fail from improper construction, soil erosion, vandalism, falling trees, vehicular accidents, and animals digging holes under the fence. We have already documented locations along the fence line where water has eroded soil creating gaps under the fence (Figure 23). Caltrans walked the entire fence line in March 2012 and identified 15 of these locations (Figure 24) where animals can fit under the fence and access the right-of-way. The entire fence line should be walked every 6 months to identify and repair any holes and breaks.

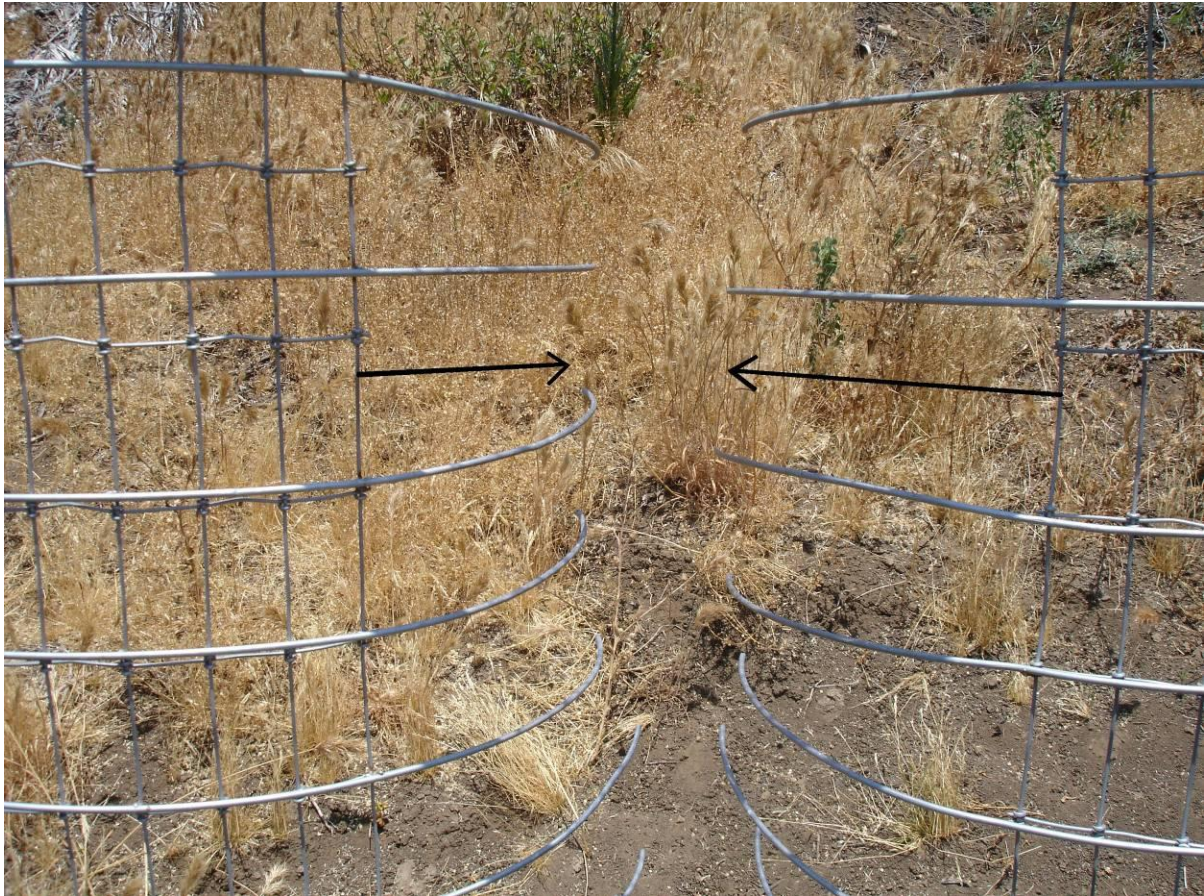
**Figure 25.** The wire mesh should extend out to the tine ends to improve the one-way gates so animals cannot pass through the wrong way.

**B. Consider improving the one-way gate design to be more effective in keeping animals and people from entering the right-of-way through it.** Our modified one-way gate design resulted in animals passing through the gate the intended way two-thirds of the time. However, we believe the design can be improved by extending the 5 x 10 cm wire mesh out to the end of the tines (Figure 25). A gap of 5 cm between the tine ends should still be kept in place. This should prevent animals from passing through the gate the wrong way between the tines (Figure 26), and should strengthen the tines and prevent them from bending and breaking off (Figure 27). Even with the wire mesh extended to the tine ends, there should still be enough flexing to allow animals to push through. All wildlife species showed the ability to pass through the small gap between the tine ends and flex the gate open (Figure 28). If the tines appear not to flex enough after extending the wire mesh to the tine ends, then a thinner gauge wire mesh could be used. Testing and monitoring of the updated gate design would be required to evaluate its effectiveness. Some of the gates, especially the ones used by people, need repair by replacing bent tines and adding tines that have been broken off. Spring-loaded swing gates (Clevenger and Huijser 2010) should also be added in the fence next to the one-way gates to allow passage for people and prevent them from going through the one-way gates. This should help reduce human damage to the one-way gates and tines. To keep costs down, the spring-loaded gates (Figure 29) can be placed at the 6 gates (3 on each side of freeway) that showed use by people (Gates 1W, 2W, 4E, 4W, 5E, 6E). Gates 4E and 5E showed the most use (76%) by people. Signs in English and Spanish should be placed at each gate directing them to use the spring-loaded swing gate and not the wildlife one-way gate. All one-way and spring-loaded swing-gates should be checked every 6 months to ensure they are functioning properly and identify and repair any broken parts.

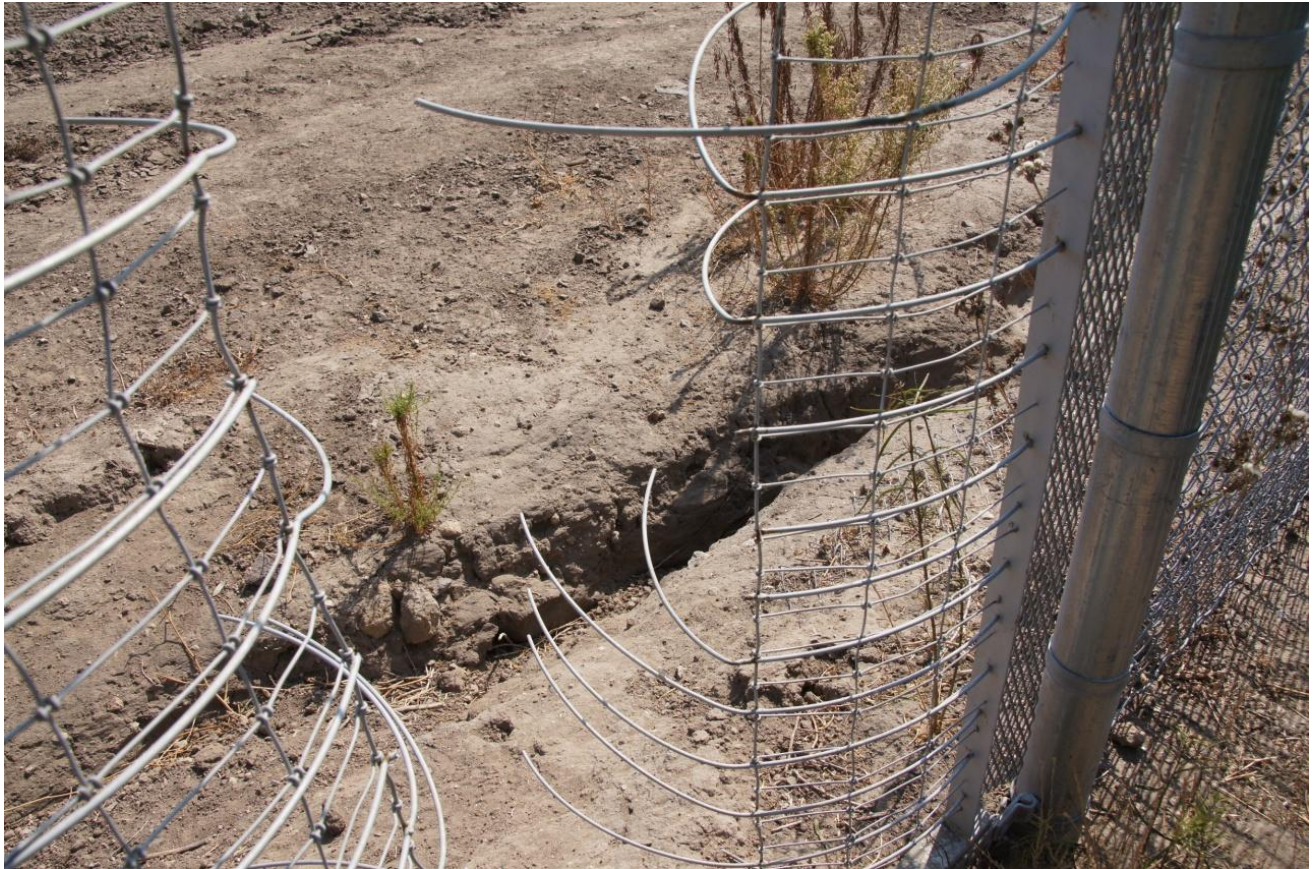
**Figure 27.** Tines bent and broken off from people using the one-way gate.

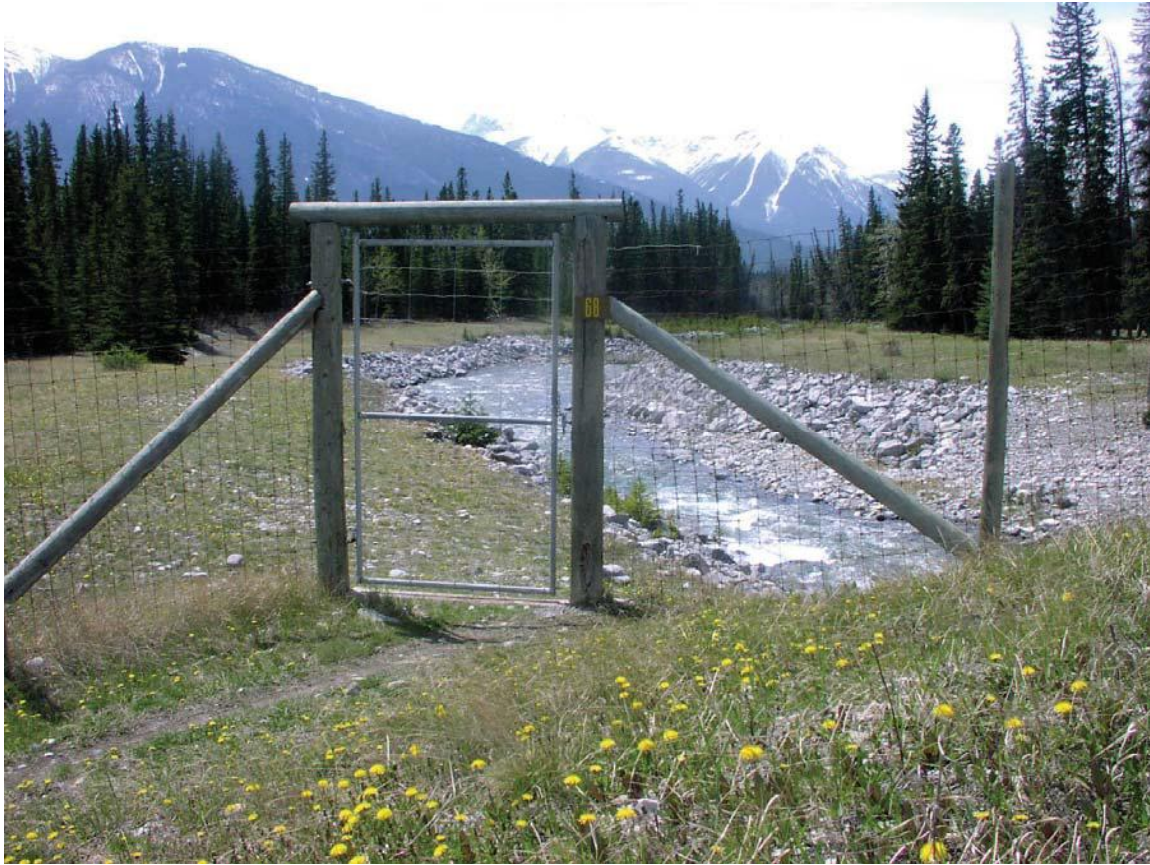
**Figure 29.** Spring-loaded swing gate in wildlife exclusion fence (Credit: Tony Clevenger).

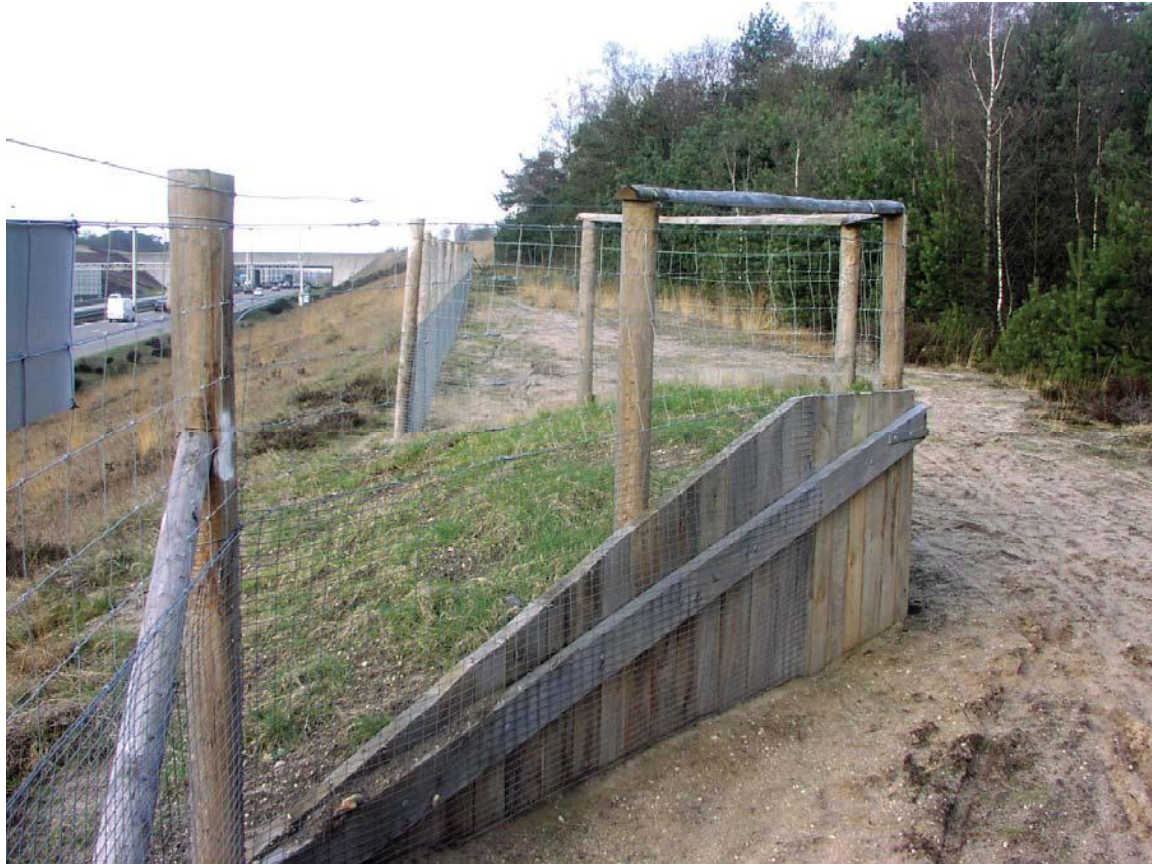
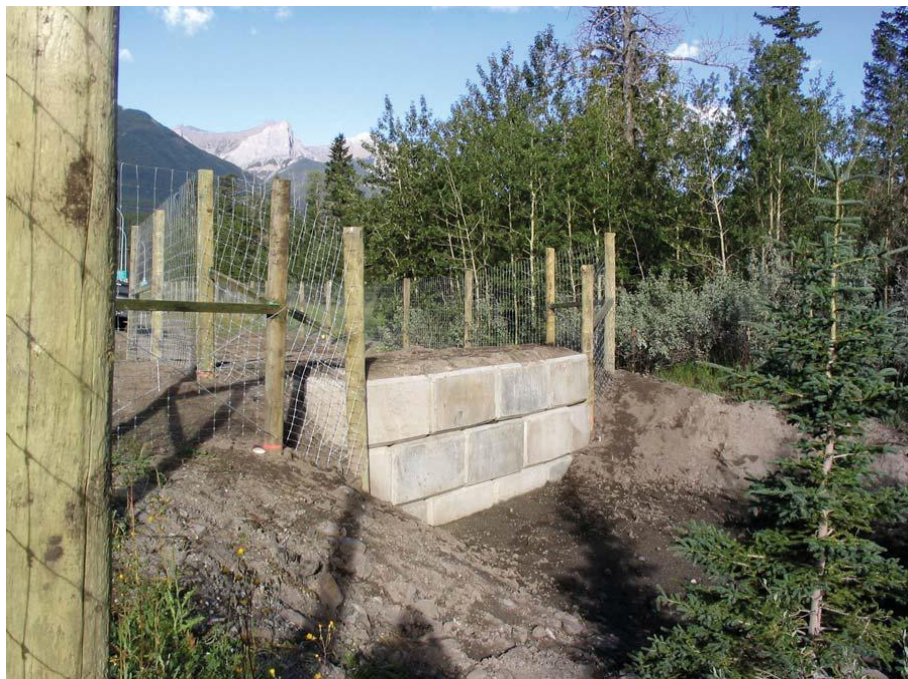
**Figure 30.** Examples of escape ramp (jump-out) for wildlife trapped inside the fenced highway right-of-way (Credit: Tony Clevenger).

Caltrans should consider earthen escape ramps (or jump-outs) to allow wildlife, especially deer, to safely exit the right-of-way in place of one-way gates in future highway mitigation projects (Forman et al. 2003). Earthen escape ramps are an alternative to one-way steel gates and have been shown to be 6 to 12 times more effective than gates in allowing deer to escape the right-of-way (Bissonette and Hammer 2000). Earthen escape ramps are mounds of dirt placed against a backing material constructed on the right-of-way side of the fence that allow animals to jump down to the non-highway side of the fence (Figure 30). The outside walls of the escape ramp must be high enough to discourage animals from jumping onto the ramp and entering the right-of-way. To prevent injury to the jumping animal, the landing spot should consist of loose soil and be free of vegetation. Deer and elk have been found to be the most common users, but bighorn sheep, bears, moose, and cougars have been documented to use the ramps as well

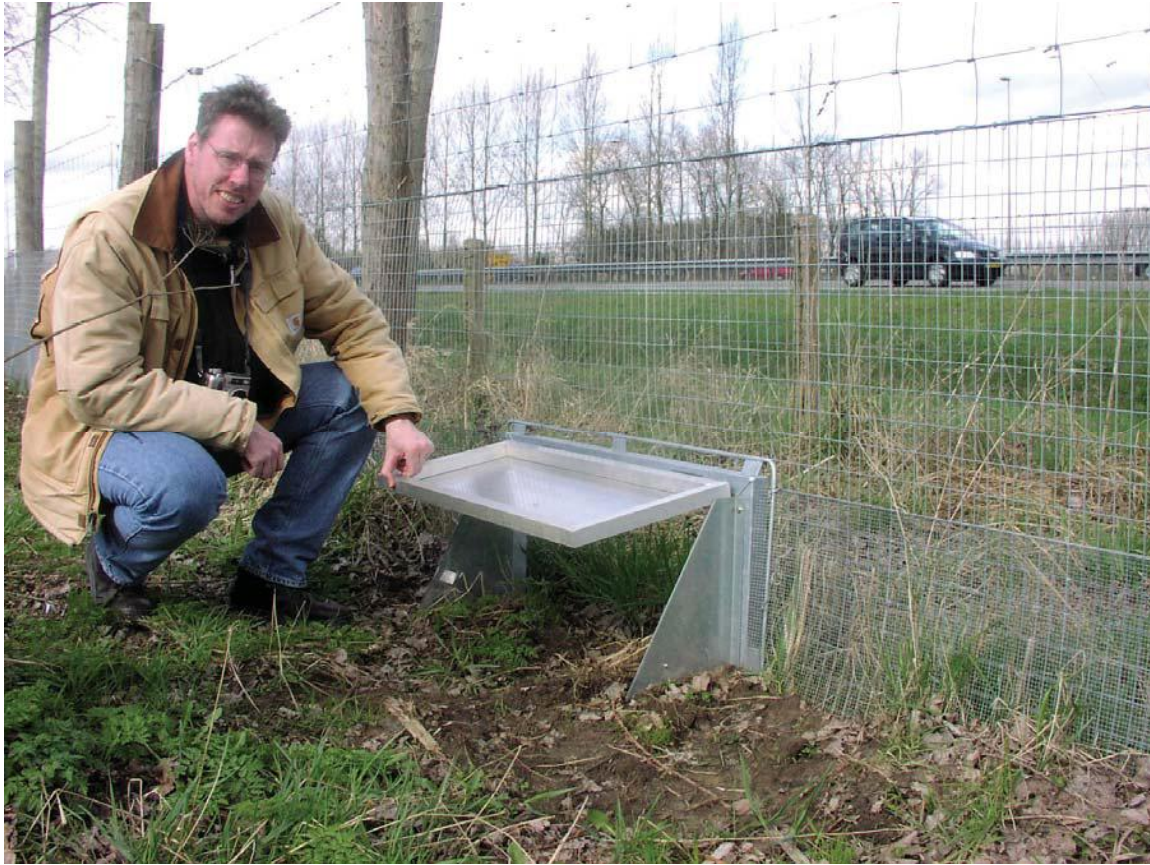
**Figure 31.** Small hinged door in wildlife exclusion fence for escape of medium-sized mammals (Credit: Tony Clevenger).

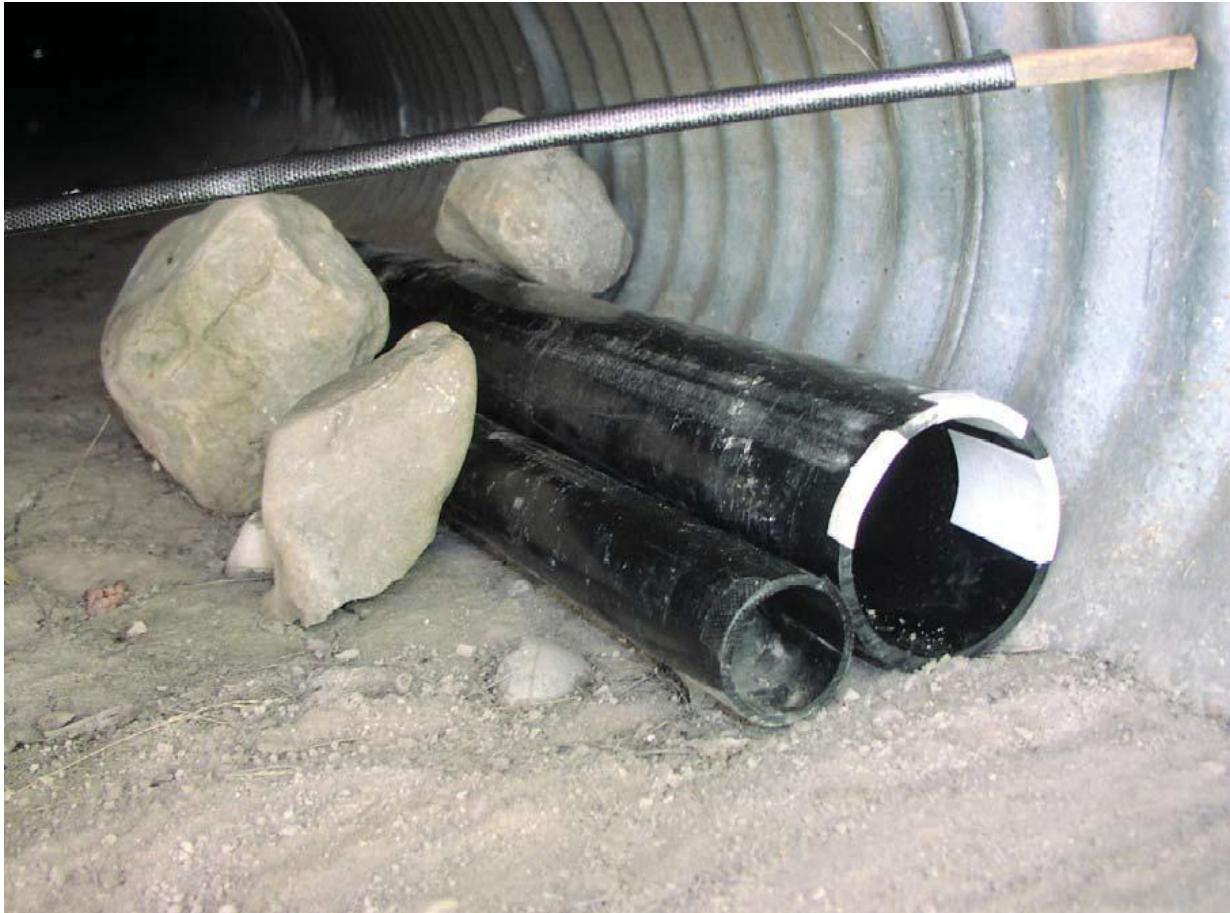
**Figure 32.** Example of pipes placed in culvert to provide cover for small mammal passage (Credit: Tony Clevenger).

**D. Add continuous cover throughout Culverts A and B to ensure their use by smaller mammal species.** We did not record any complete crossings by small mammals, indicating that the culverts are not effective for passage by these species. Smaller sized mammals, particularly prey species, tend to use passages of a size that allow for their movement, but restricts the movement of their larger predators. In the drier culverts, the cover requirements of smaller mammals may be met by placing pipes or tubes of varying diameter (Figure 32) in the culverts along one side that span the entire length. Cover within the culvert can also be in the form of logs, rock piles, and bushes (Cavallaro et al. 2005, Cramer and Bissonette 2005, Clevenger and Huijser 2010). Modifications creating smaller scale cover in Culverts A and B may encourage use by small mammals, reptiles, and species associated with rocky habitats. Mitigation measures that accommodate the needs of small-sized mammal species will require further monitoring to determine effectiveness. A culvert that incorporates multiple mitigation design elements will be most effective in encouraging wildlife passage for a variety of species.
